Oil Fumes, Flight Safety, and the NTSB

Abstract: During its investigations into a series of ten aircraft crashes from 1979 to 1981, US National Transportation Safety Board (NTSB) officials were presented with a hypothesis that “several” of the crashes could have been caused by pilot impairment from breathing oil fumes inflight. The NTSB and their industry partners ultimately dismissed the hypothesis. The authors reviewed the crash reports, the mechanics of the relevant engine oil seals, and some engine bleed air data to consider whether the dismissal was justified. Four of the nine aircraft crash reports include details which are consistent with pilot impairment caused by breathing oil fumes. None of the tests of ground-based bleed air measurements of a subset of oil-based contaminants generated in the engine type on the crashed aircraft reproduced the inflight conditions that the accident investigators had flagged as potentially unsafe. The NTSB’s conclusion that the hypothesis of pilot incapacitation was “completely without validity” was inconsistent with the evidence. Parties with a commercial conflict of interest should not have played a role in the investigation of their prod

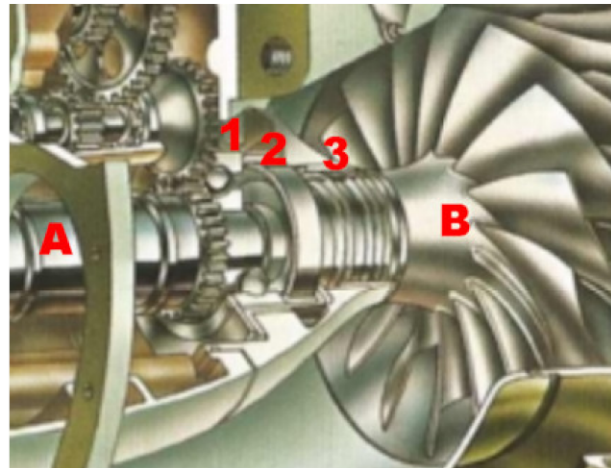
Figure 4. Garrett TPE331 turboprop engine cutaway drawing (detail based on [20]). A. main shaft. B. first-stage centrifugal compressor. 1. compressor bearing (a ball-bearing). 2. carbon seal. 3. labyrinth seal.

In the TPE331 front main shaft compressor seal assembly, two seals are used, acting in series. They prevent the escape of the engine lubricant present in the reduction gearbox via the main shaft and through the compressor bearing into the compressor (Figure 4). The following detailed explanations are reproduced with text elements from [16]:

“First, a mechanical (carbon) seal is provided to prevent leakage if operating oil pressures exceed normal pressures and to prevent potential leakage that might occur during engine

shutdown. The mechanical seal potentially is subject to wear and damage" [16] (p. 2). "When the engine is shutdown, oil drains from the engine walls which increases the oil level above the shaft installation level of the compressor front main shaft; without a mechanical seal, the oil would leak from the reduction gearbox, out the engine inlet and onto the ground. Therefore, a mechanical (carbon-element) seal is necessary to prevent oil leakage when the engine is not operating" [16] (p. 33). This is illustrated in Figure 5.

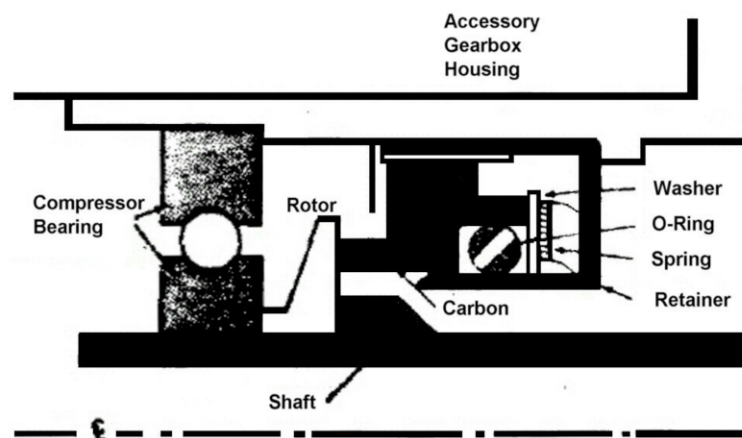
Figure 5. Mechanical (carbon) seal assembly next to the main shaft compressor bearing on the TPE331 engine (based on Figure 3 in [16]).

The description in [16] of the two seals in series contains some contradictions. According to the explanation, the carbon seal is necessary because “when the engine is shutdown, oil drains from the engine walls which increases the oil level above the shaft installation level of the compressor” [16] (p. 33). The labyrinth seal is necessary because the carbon seal is potentially “subject to wear and damage” [16] (p. 2). So, if the carbon seal is worn or damaged, then the oil will flow out of the reduction gearbox into the compressor and contaminate the cabin air when the engine is next started up. This situation was investigated in test 5 [16].

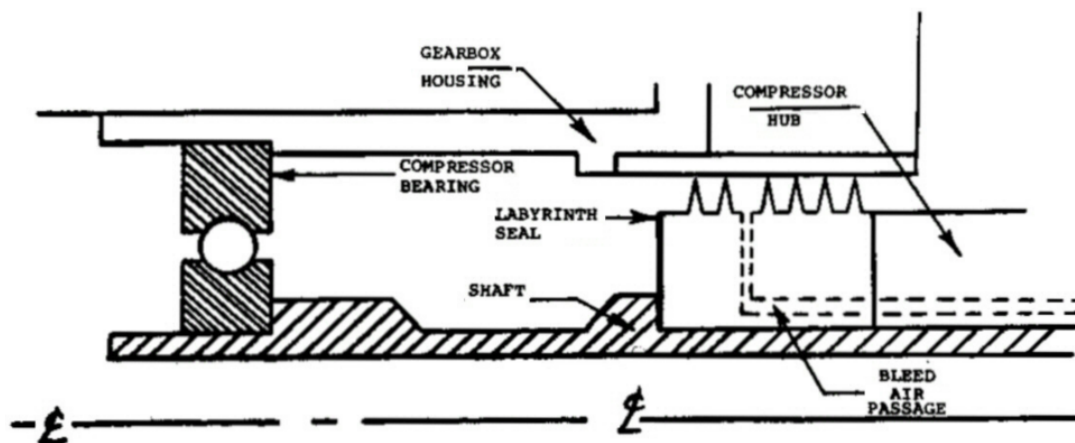
Figure 6. Labyrinth seal close to the main shaft compressor bearing (based on Figure 11 in [16]). Note: The carbon seal is located in between the compressor bearing (on the left) and the labyrinth seal (on the right) in the empty space but is not shown in this figure.

"Secondly, the TPE331 has a pressurized knife-edge labyrinth air seal that is specifically designed to prevent passage of air/oil mist from the reduction gearbox into the compressor chamber during engine operation" [16] (p. 2). "This pneumatic-type seal is pressurized to approximately 26 psi (1.79 bar) at the inner knife edges. When the engine is operating, the pneumatic seal is independently capable of preventing the air/oil mist from passing out of the reduction gearbox because of a flow of pressurizing air from the seal into the reduction gearbox. However, the labyrinth seal has no sealing capability to prevent engine oil from exiting the reduction gearbox when the engine is not operating and, therefore, requires a mechanical seal to prevent oil leakage when the engine is shut down. The symptom of a failed mechanical seal is oil leaking past the labyrinth seal and running out the engine inlet onto the ground when the engine is not operating" [16] (p. 35). The bleed air passage directs sealing air from the compressor to the labyrinth seal. All of this is illustrated in Figure 6 and additional details are shown in Figure 7.

It is known that all seals leak in small quantities [38]. Pressure differentials assumed by the manufacturer may not be present in failure cases. Moreover, pressure differentials may not be sufficient during rapid thrust reduction or at idle thrust. In test 4, it was assumed only that one of the two seals in series (the carbon seal) would have failed. The labyrinth seal was left intact. Certainly, a mechanical failure that causes the carbon seal to fail may also cause the labyrinth seal to fail at the same time. For example, a failure of the main shaft compressor bearing could cause the main shaft to vibrate or rotate eccentrically which could severely damage (or even destroy) both seals.

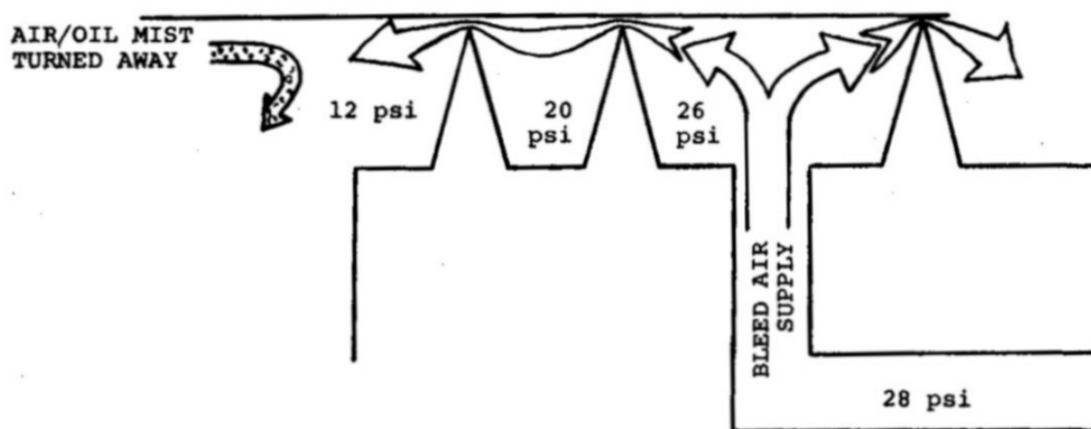
Figure 7. Flow through the labyrinth seal in the TPE331 engine next to the compressor bearing and resulting pressure. The flow to the left pushes back the oil that still comes through the carbon seal (based on Figure 13 in [16]).

“The pressure balances that are maintained may be clearly understood by considering that the chamber containing the air/oil mist operates at approximately 12 psia (−2 psig) while the center of the labyrinth is pressurized to 26 psia (+12 psig). Since air will always flow from a higher pressure area to a lower pressure area, air will flow outward from the center of the labyrinth. Each of the knife-edges operates with only slight clearance from the outer wall, resulting in a high local velocity as the air crosses into the next chamber. With a high local velocity, the air/oil mist cannot flow past the knife edges and enter the compressor air flow” [16] (p. 36). This is illustrated in Figure 7.
