# Geotechnical Assessment of Seismic Vulnerability in the Built Environment of Fako Division, South West Region of Cameroon

Original Research Article

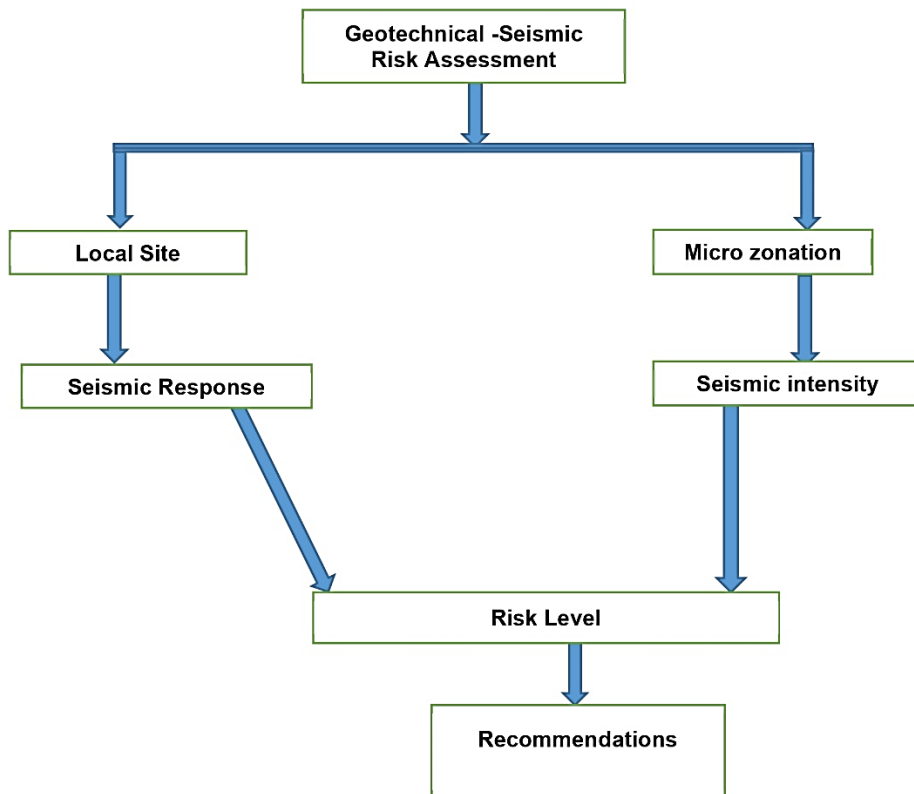
Fig. 2. Risk assessment framework for Mt Cameroon Area

Having researched the literature described above, a framework for assessing seismic risk within Mount Cameroon area is schematically represented (Fig. 2).

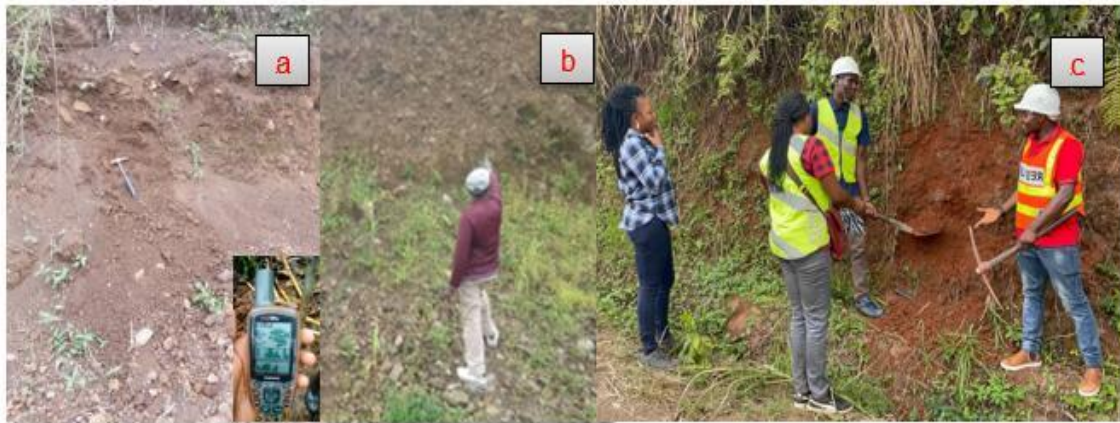
**Fig. 3. Field survey and sample collection showing: a. GPS Points recording and marking of outcrops, b. geologic description & c. sample collection**

Reconnaissance survey was conducted in various localities to gather crucial information about the study area, develop survey strategies, and overcome potential shortcomings. The survey involved physical observation, geological descriptions, and marking outcrops for geological analysis prior to soil sample collection from sixteen sample points. Detailed descriptions including the name of the locality, rock/soil type, and soil characteristics were recorded during this phase for all the 16 points. GPS points and photographs were taken to produce a geologic map and provide a true depiction of the area's geology (Fig. 3).

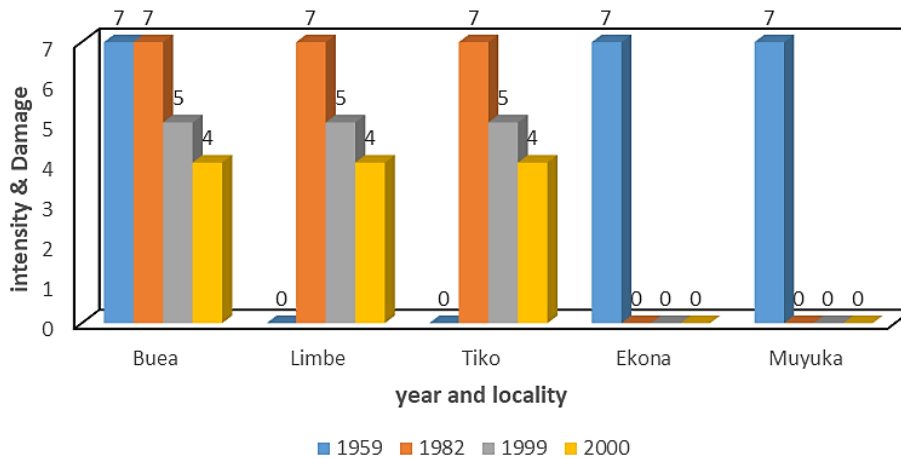
**Fig. 7. Intensities and associated impacts (damages) from the 1959, 1982, 1999 & 2000 eruptions**

The 1999 eruption had a higher impact in Buea as a whole than other areas (Figs. 7 & 8) when compared to the 1959 and 1982 events with major and minor damages greatly felt in Bokwango, Buea Town, Small Soppo, Bonduma, Molyko, Bomaka and Muea. However, some houses experienced no effects. This high impact within the city of Buea could be linked to the fact that the epicentre of the quake was within the city.

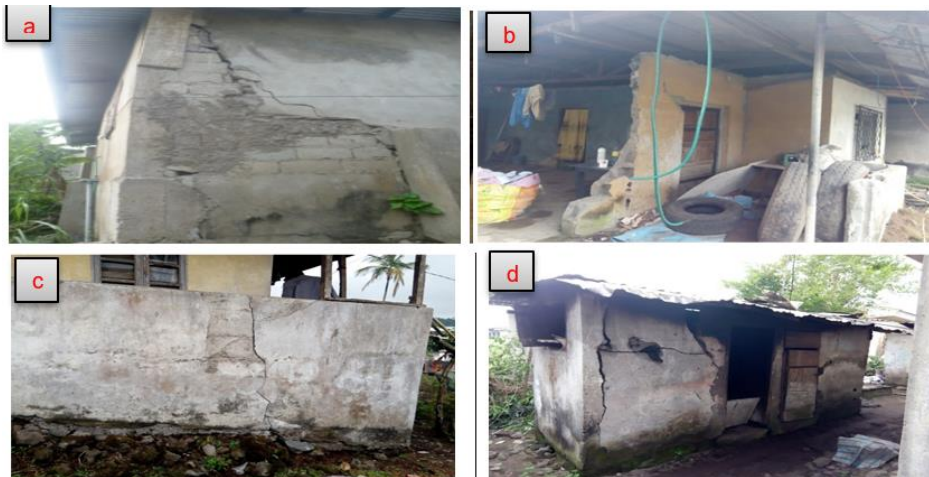
**Fig. 8. Damaged buildings in Buea during the 1999 eruption at: a. Small Soppo, b. poto-poto quarter-Bokwango, c. Buea Town and d. Small Soppo**
